## Test Report - Commercial in Confidence X0032 Bailey Street Furniture Inspira Protect Planter

Test Laboratory	HORIBA MIRA Ltd
Date of Report	25/01/2022
Client	Centre for the Protection of National Infrastructure (CPNI)
Test Item	Inspira Protect Planter
Date of Test	10/09/2020
Test Number	X0032
Report Number	1223164-004-005-03
Test Type	Vehicle Impact
Product Rating	IWA 14-1:2013 Planter V/1500[M1]/48/90:0.0
Number of Pages	21

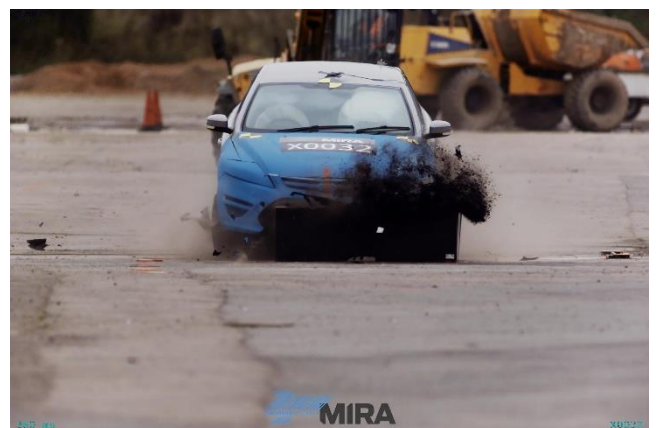
On first contact with the planter, the front plastics of the vehicle crushed. The front bumper bar and chassis then engaged with the planter and the vehicle began to ride up the front face, which was bent forward during the impact. All four wheels on the vehicle lost contact with the ground before coming back down and finally coming to rest with slight rearwards movement.

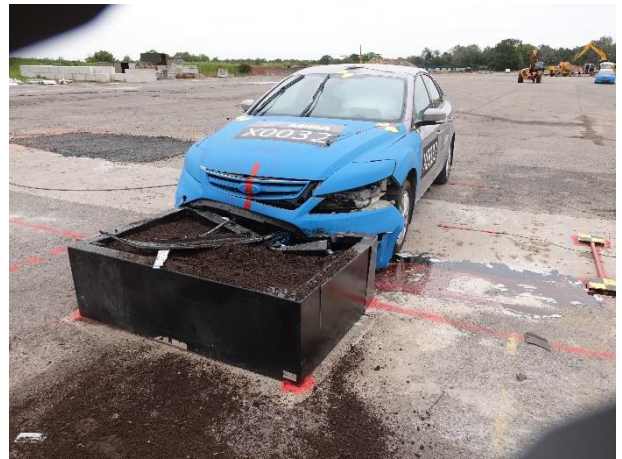
The front face of the planter was bent forward to 54.5° in the impact, with the fixings on the LHS vertical seam pulling through the steel. A small amount of soil was thrown forwards. The top edge was rolled over and a corner support was left exposed. There was no forwards movement of the planter from the original position. The foundation to the front and rear of the unit was intact. Following removal of the unit, there was damage around the fixing points along the front edge.

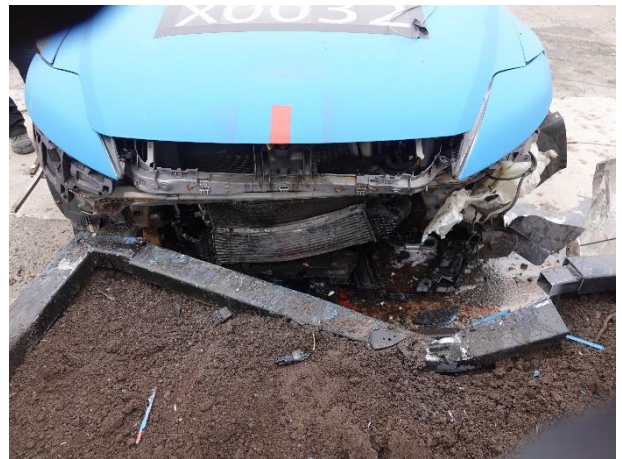
The front bumper and plastics were damaged and the front airbags were deployed. The intercooler and all cooling pack components were damaged, and the engine/gearbox was leaking oil. There was damage to bumper bar and chassis rail ends. The vehicle was disabled and unable to start post impact.
