Test Report - Commercial in Confidence A0011 Bailey Street Furniture Protect Tandem Cycle Parking

Test Laboratory	HORIBA MIRA Ltd
Date of Report	26/05/2022
Client	Centre for the Protection of National Infrastructure (CPNI)
Test Item	Dual cycle stands with core posts
Date of Test	23/03/2022
Test Number	A0011
Report Number	1225361-004-021-01
Test Type	Vehicle Impact
Product Rating	IWA14-1:2013 Barrier V/2500[N1G]/48/90:0.0
Number of Pages	30

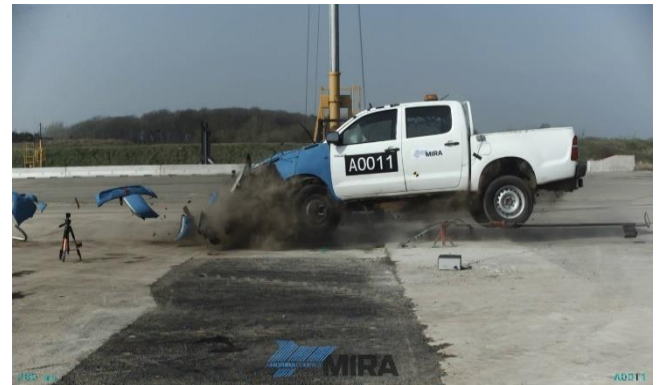
The target impact point was the centreline of the vehicle aligned to the centre of the gap between the cycle stands. The initial contact with the cycle stands was made by the bumper which deformed and split open to both sides, the vehicle continued, and the cycle stands went through the bumper fully. The vehicle steering linkages and wishbones contacted the cycle stands deforming rearwards. The front wheels/tyres contacted the rear of the inner wheel arches and front floor. The vehicle lifted from the ground and began to partially rebound. The vehicle returned fully to ground with the front remaining trapped and entangled with the cycle stands.

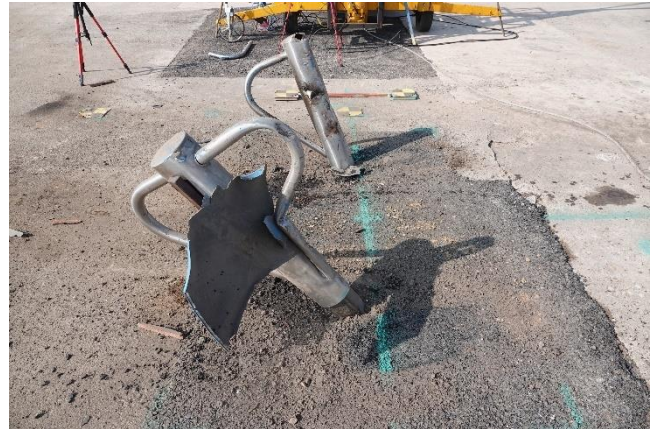
The impacted cycle stands sleeves remained attached to the core posts. The RH sleeve had some distortion, scraping and tearing visible, the front arm tube was fully detached and came to rest X 44.0m, Y-1.9m with a mass of 2.3kg. The detached arm tube was not classified as major debris and is for reference only. The LH sleeve had some distortion, scraping and deformation to the front arm tube. The RH core post had no major damage visible to the inner or outer core with only bending at ground level and movement of 19.1° in the impact direction. The LH core post had bending at ground level and movement of 35.5° in the impact direction. The weld joining the LH inner and outer core posts at the top was broken and the inner post was sitting marginally recessed to the outer post. The front face of the LH outer core post at ground level was torn through exposing the inner core post. The foundation had no major damage visible and residual movement of 0.7° in the impact direction. The tarmac to front edge of the foundation was marginally lifted with a small gap present showing movement.

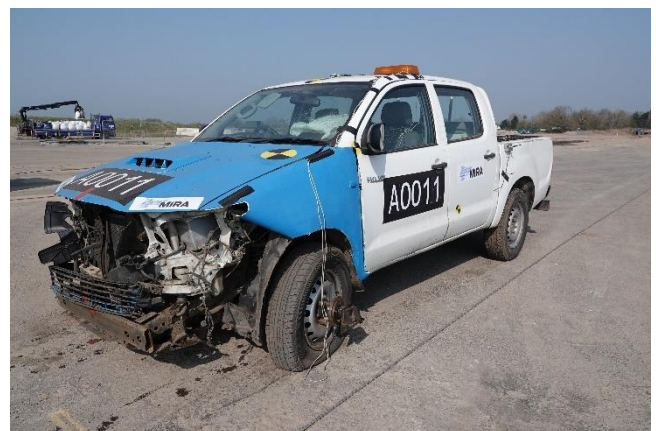
The vehicle airbags were deployed, and damage was sustained to the front slam panel including inner wing structures. The engine remained running with only a minor coolant leak. The vehicle had damage to the front steering and suspension components. The LH steering link was deformed along with the lower LH wishbone and mounting bracket. The RH steering link was detached from the hub carrier and the lower RH wishbone detached from the front mounting bracket fully. The upper RH wishbone was detached from the hub carrier at the ball joint connection. The RH drive driveshaft was damaged, and the CV joint separated from the differential. The vehicle was attempted to be driven but was unable to be disengaged from the product with the rear wheels spinning and losing traction. The vehicle was fully disabled.
