Test Report - Commercial in Confidence Y0019 Bailey Streetscene Ltd Inspira Protect Litterbin

Test Laboratory	HORIBA MIRA Ltd
Date of Report	26/04/2021
Client	Centre for the Protection of National Infrastructure (CPNI)
Test Item	Litterbin on HVM Post
Date of Test	24/03/2021
Test Number	Y0019
Report Number	1223164-004-028-01
Test Type	Vehicle Impact
Product Rating	IWA 14-1:2013 Barrier V/1500[M1]/48/90:2.2
Number of Pages	25

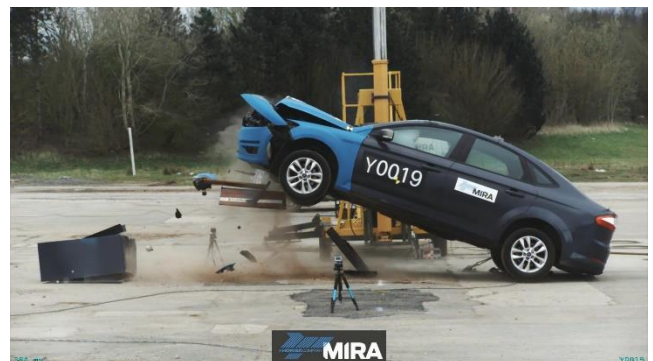
The test vehicle impacted and the front bumper collapsed around the product. The airbags deployed and the bonnet crushed. The bin core bent rearwards, in the impact direction and the bin detached and slid along the floor. The front of the vehicle began to rise as it ran up the core post which was now exposed. The front of the vehicle continued to rise, and the rear bumper grounded causing the lower trim to detach. The rear access panel of the product and wooden trim released from under the front of the car and travelled forward in the direction of impact. The vehicle landed with the core post mid-way underneath the car, and hit the underbody forcing the car onto its steering axle and then onto its RHS wheels before coming to rest beached on top of the post.

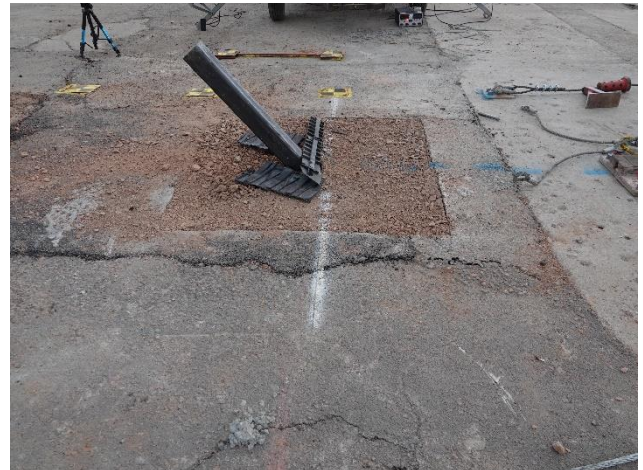
The main bin structure was detached and ejected from the core post, landing 10.5m forward of the datum line with a piece of wooden trim at 7.9m and the fascia panel at 5.6m. The core post was still connected to the foundation and was bent forward by 40°. The outer 100x100x8mm post had sheared through on the impact face exposing the 80x80x8mm post inside. There was some sign of movement in the surface in front of the product with slight cracking observed. Upon removal the concrete foundation below the compacted surface showed no visible signs of a cracking or damage.

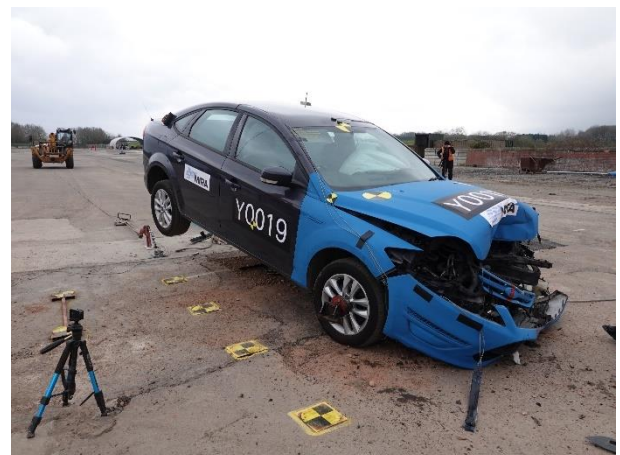
The front bumper was damaged. The cooling pack and radiator had been crushed and split in the centre. The slam panel was exposed, and the bonnet would not open due to deformation. All front airbags were deployed. The vehicle stopped running during test and was unable to be started post impact. The front underside of the car showed signs of contact with the post and the impact had pushed the floor pan to the rear of the passenger seat rails upwards. All four doors and boot could be opened but it was noted that the passenger seat had moved by contact with the passenger door and B -post. The rear footwell was lifted by 130mm and the centre console was pushed over into the driver’s seat.
