Test Report - Commercial in Confidence A0011 Bailey Street Furniture Protect Tandem Cycle Parking

Test Laboratory	HORIBA MIRA Ltd
Date of Report	26/05/2022
Client	Centre for the Protection of National Infrastructure (CPNI)
Test Item	Dual cycle stands with core posts
Date of Test	23/03/2022
Test Number	A0011
Report Number	1225361-004-021-01
Test Type	Vehicle Impact
Product Rating	IWA14-1:2013 Barrier V/2500[N1G]/48/90:0.0
Number of Pages	30

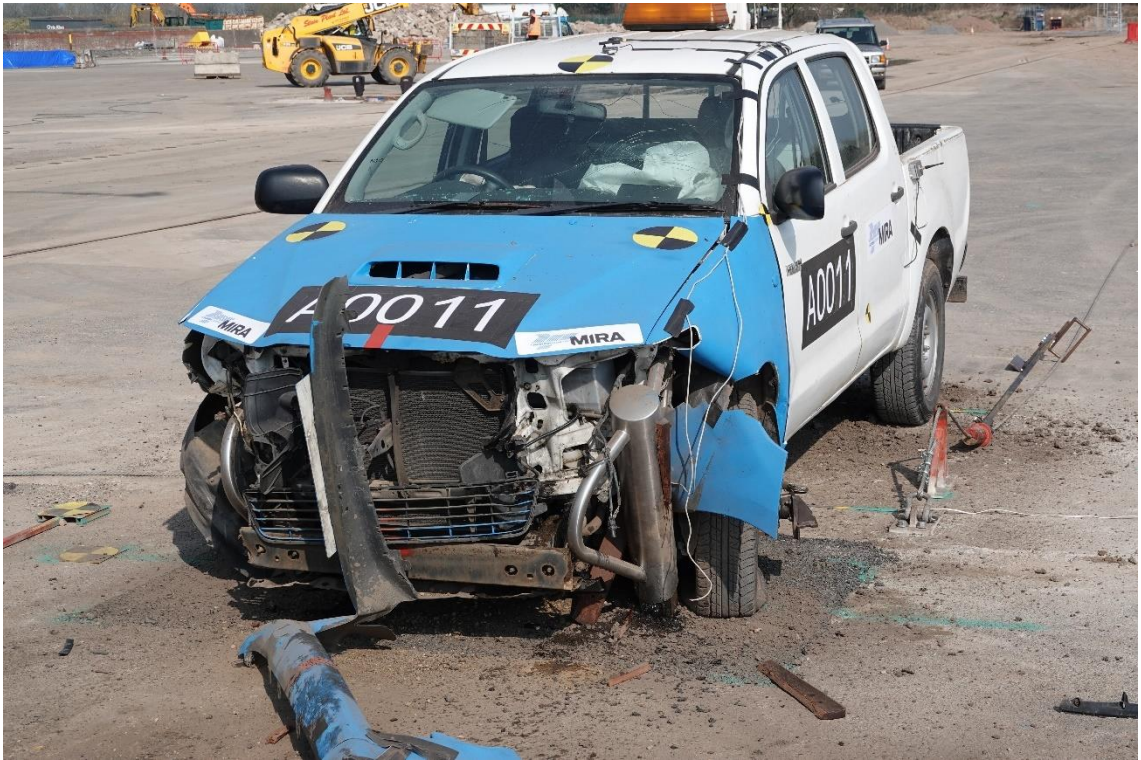
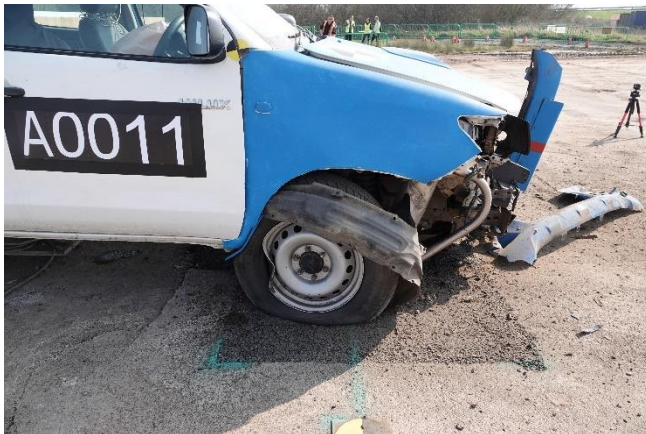
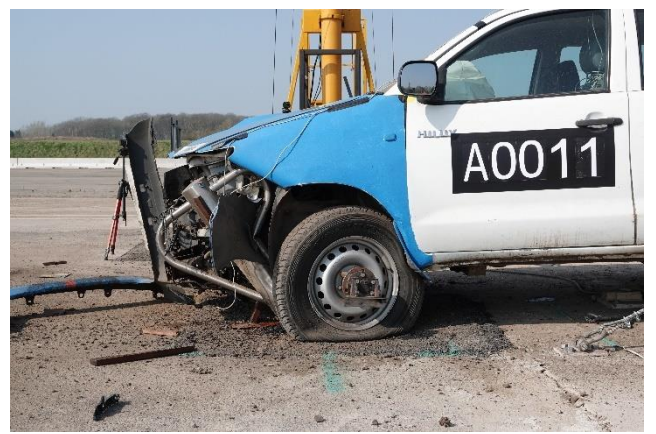
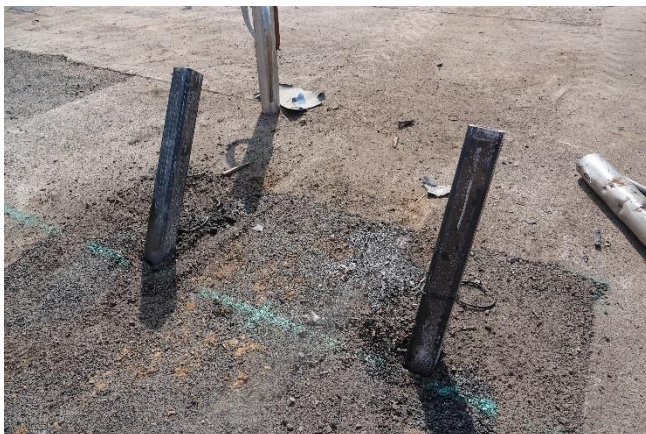
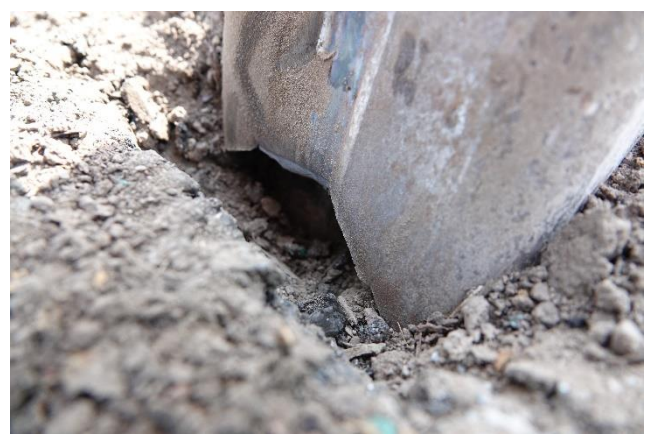
9 Post Impact Product and Vehicle Images

The impacted cycle stands sleeves remained attached to the core posts. The RH sleeve had some distortion, scraping and tearing visible, the front arm tube was fully detached and came to rest X 44.0m, Y-1.9m with a mass of 2.3kg. The detached arm tube was not classified as major debris and is for reference only. The LH sleeve had some distortion, scraping and deformation to the front arm tube. The RH core post had no major damage visible to the inner or outer core with only bending at ground level and movement of 19.1° in the impact direction. The LH core post had bending at ground level and movement of 35.5° in the impact direction. The weld joining the LH inner and outer core posts at the top was broken and the inner post was sitting marginally recessed to the outer post. The front face of the LH outer core post at ground level was torn through exposing the inner core post. The foundation had no major damage visible and residual movement of 0.7° in the impact direction. The tarmac to front edge of the foundation was marginally lifted with a small gap present showing movement.

The vehicle airbags were deployed, and damage was sustained to the front slam panel including inner wing structures. The engine remained running with only a minor coolant leak. The vehicle had damage to the front steering and suspension components. The LH steering link was deformed along with the lower LH wishbone and mounting bracket. The RH steering link was detached from the hub carrier and the lower RH wishbone detached from the front mounting bracket fully. The upper RH wishbone was detached from the hub carrier at the ball joint connection. The RH drive driveshaft was damaged, and the CV joint separated from the differential. The vehicle was attempted to be driven but was unable to be disengaged from the product with the rear wheels spinning and losing traction. The vehicle was fully disabled.
