Test Report - Commercial in Confidence Y0019 Bailey Streetscene Ltd Inspira Protect Litterbin

Test Laboratory	HORIBA MIRA Ltd
Date of Report	26/04/2021
Client	Centre for the Protection of National Infrastructure (CPNI)
Test Item	Litterbin on HVM Post
Date of Test	24/03/2021
Test Number	Y0019
Report Number	1223164-004-028-01
Test Type	Vehicle Impact
Product Rating	IWA 14-1:2013 Barrier V/1500[M1]/48/90:2.2
Number of Pages	25

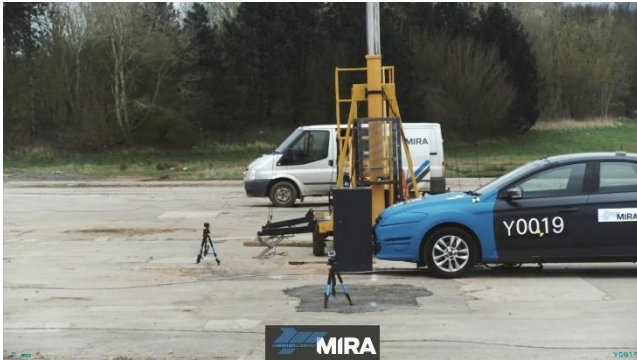
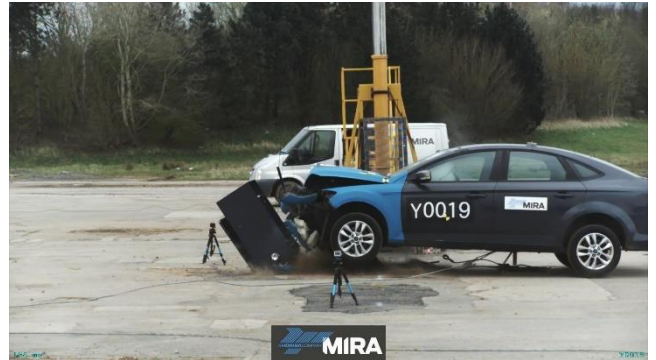
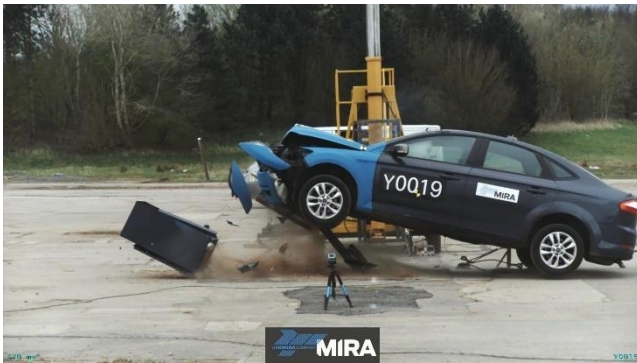
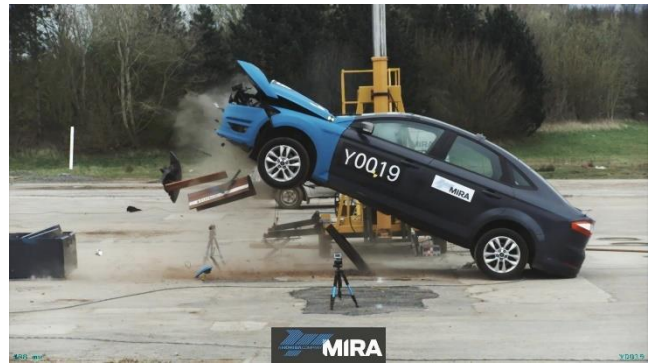
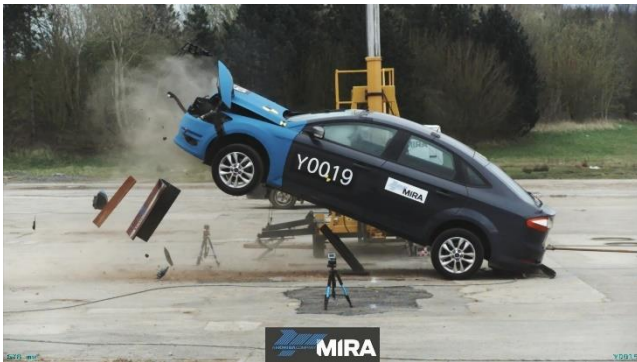
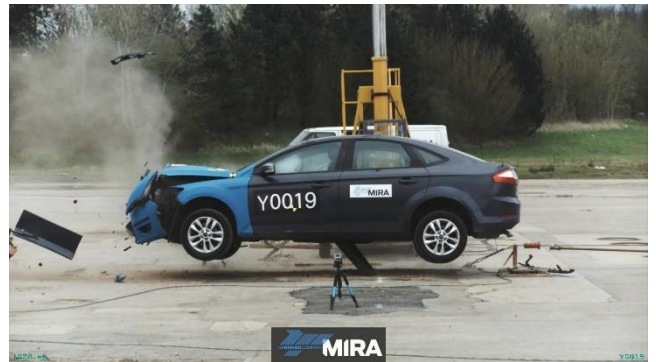
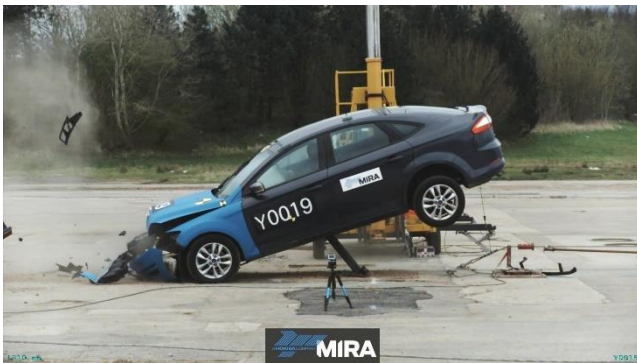
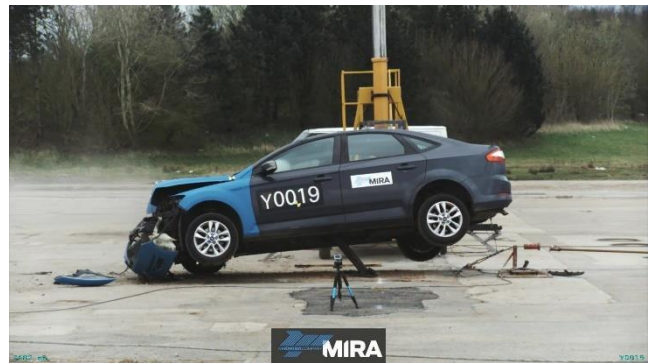
7 Side Views from High Speed Videos

The test vehicle impacted and the front bumper collapsed around the product. The airbags deployed and the bonnet crushed. The bin core bent rearwards, in the impact direction and the bin detached and slid along the floor. The front of the vehicle began to rise as it ran up the core post which was now exposed. The front of the vehicle continued to rise, and the rear bumper grounded causing the lower trim to detach. The rear access panel of the product and wooden trim released from under the front of the car and travelled forward in the direction of impact. The vehicle landed with the core post mid-way underneath the car, and hit the underbody forcing the car onto its steering axle and then onto its RHS wheels before coming to rest beached on top of the post.

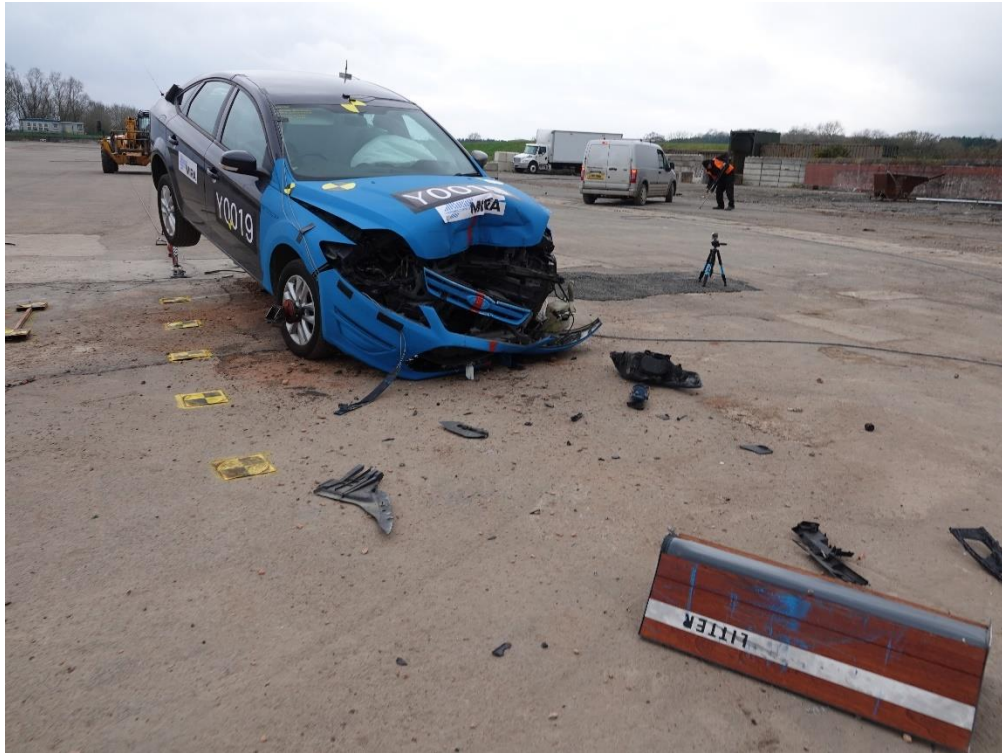
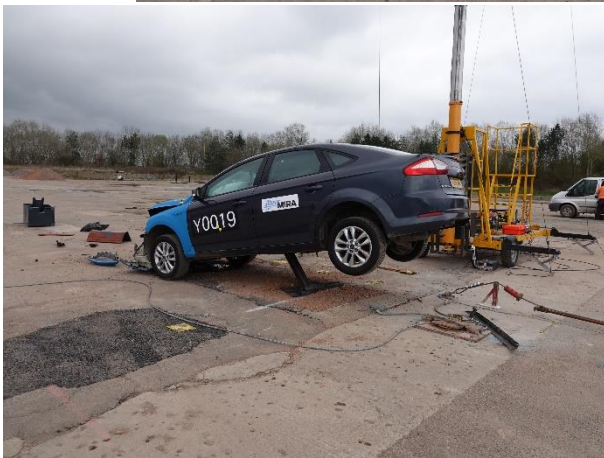
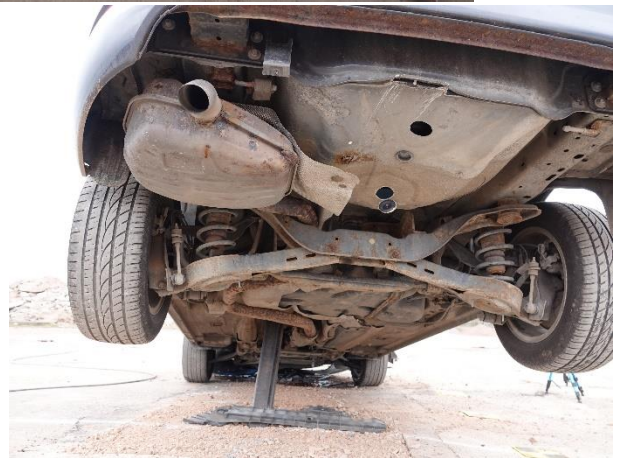
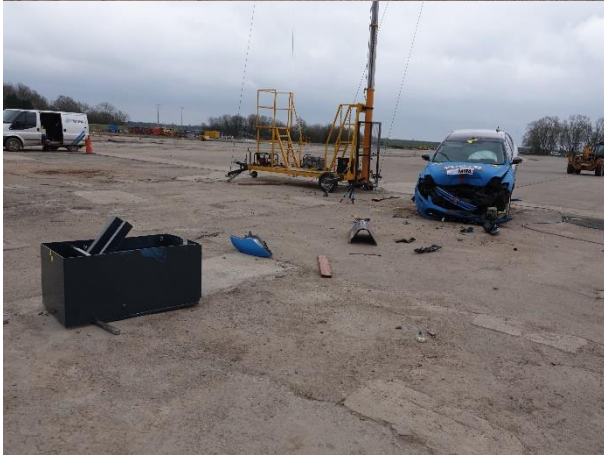
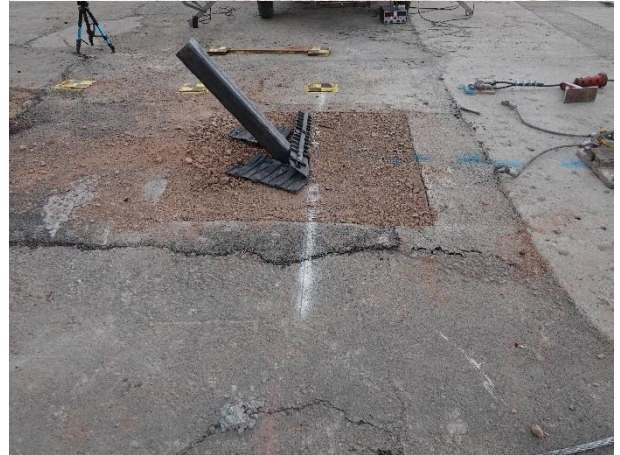
9 Post Impact Product and Vehicle Images

The main bin structure was detached and ejected from the core post, landing 10.5m forward of the datum line with a piece of wooden trim at 7.9m and the fascia panel at 5.6m. The core post was still connected to the foundation and was bent forward by 40°. The outer 100x100x8mm post had sheared through on the impact face exposing the 80x80x8mm post inside. There was some sign of movement in the surface in front of the product with slight cracking observed. Upon removal the concrete foundation below the compacted surface showed no visible signs of a cracking or damage.

The front bumper was damaged. The cooling pack and radiator had been crushed and split in the centre. The slam panel was exposed, and the bonnet would not open due to deformation. All front airbags were deployed. The vehicle stopped running during test and was unable to be started post impact. The front underside of the car showed signs of contact with the post and the impact had pushed the floor pan to the rear of the passenger seat rails upwards. All four doors and boot could be opened but it was noted that the passenger seat had moved by contact with the passenger door and B -post. The rear footwell was lifted by 130mm and the centre console was pushed over into the driver’s seat.
